State of California
The Resources Agency
DEPARTMENT OF WATER RESOURCES
DIVISION OF SAFETY OF DAMS

INSPECTION OF DAM AND RESERVOIR IN CERTIFIED STATUS

Name of dam Oroville Dam Dam No. 1-48 County Butte
 Type of dam Earthfill Type of Spillway Gated Concrete Weir and Chute
 Water is 114.32 feet below spillway crest and 222.52 feet below dam crest.
W.S. 898.96 feet
 Weather Conditions Sunny, and hot
 Contacts made Alex Samaan, OFD; David Panec O&M.
 Reason for inspection Periodic Evaluation (2nd inspection)

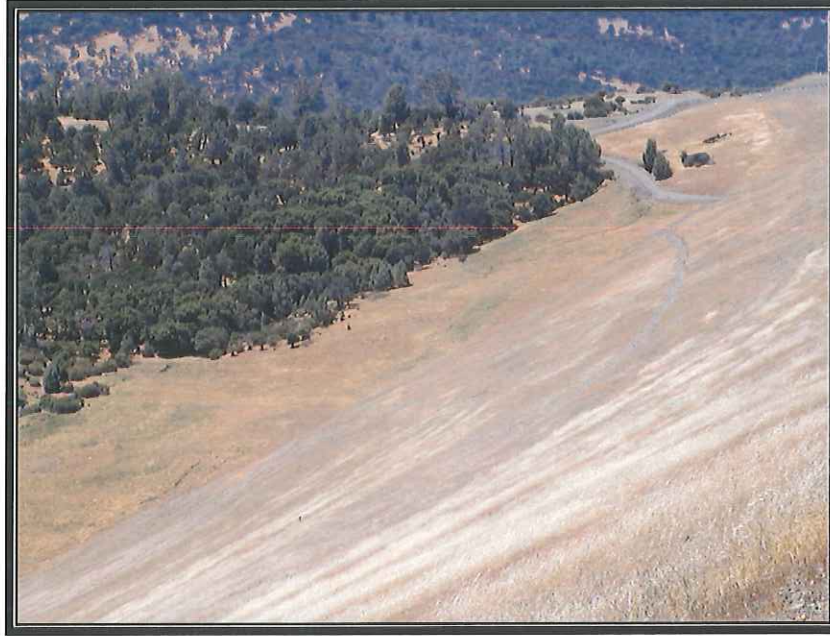
Item No.*	Item Name and Observation and Comment
A1-A4	<p><u>Dam</u> - The crest roadway was in good condition, and the embankment appeared to be stable. Vegetation and rodent activity were under control. The downstream embankment is shown in photographs 1 and 2. The thick grass and weeds at the left side of the dam, see photograph 2, probably encompasses the extent of the documented seepage area.</p> <p>The field office continues to monitor the displaced riprap that was previously observed on the upstream slope, see report of 6/18/02. Paint marks on a few of the large rocks will be used to monitor movement relative to a bench mark. If no movement is observed over a two-year period, the monitoring can be terminated.</p> <p>The left and right grout galleries, the core block and the access galleries were traversed. The escape tunnel was traversed to the plug.</p> <p>The right grout gallery was entered from the top. The first seepage was observed at elevation 750. Seepage increased steadily to about 13 gpm at the sump level. Nothing unusual was observed.</p> <p>The left gallery was traversed from the sump to the upper access door. Total seepage was about the same as the right side. Nothing unexpected was observed. The field office should continue the program to remove the accumulated deposits from the floor drains, and steps.</p> <p>The access gallery and terminal S appeared unchanged. The bolts on two compression fittings along the sump pump discharge line have lost the protective coating and are heavily rusted.</p>

1. This view shows the downstream embankment as seen from the left groin.

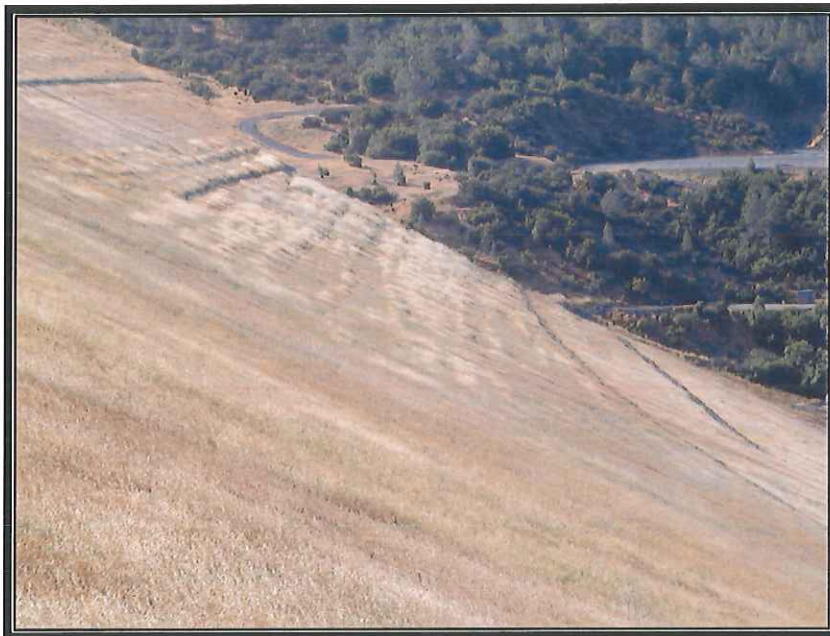
2. Note the thick grass and weed cover at the left end of the dam. This growth may define the seepage area that has been referred to by others over the years. No seepage was observed during the inspection.

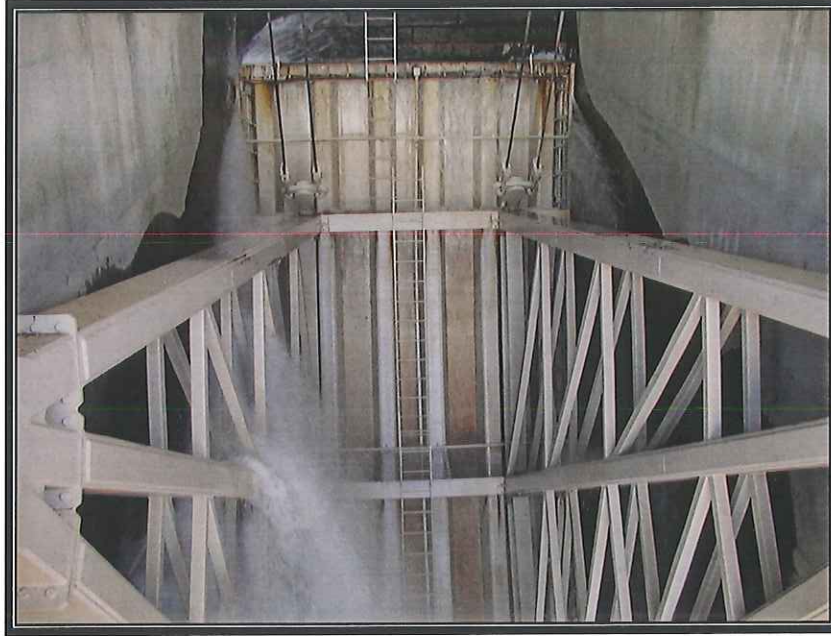
<p><u>Palermo Tunnel</u> - The tunnel was not entered. Seepage exiting the tunnel appeared to be normal.</p>
	<p><u>Spillway</u> - The stoplogs were being installed at gate 3 during the inspection. Field staff will evaluate the leaky seals. See photograph 3.</p>
	<p>The spillway chute and walls were observed from the roadway deck, from the walkway at the trunnion level, and from the dam crest. Nothing unexpected was observed. The existing crack at the left side of bay 8 was seeping as shown in photograph 4.</p>
	<p>The flood control structure, radial gates, and mechanical equipment appeared to be in satisfactory condition. No new spalling has occurred along the left and right bridge abutments as demonstrated by the unbroken paint which is used to monitor the deterioration. The left abutment spalling is shown in photograph 4. Minor seepage was noted at the outside edge of the bay 8 wall as shown in photograph 5.</p>

3. Seal leakage at gate 3 is shown. During the inspection, the stoplogs were installed in preparation for an evaluation of the sealing problem.

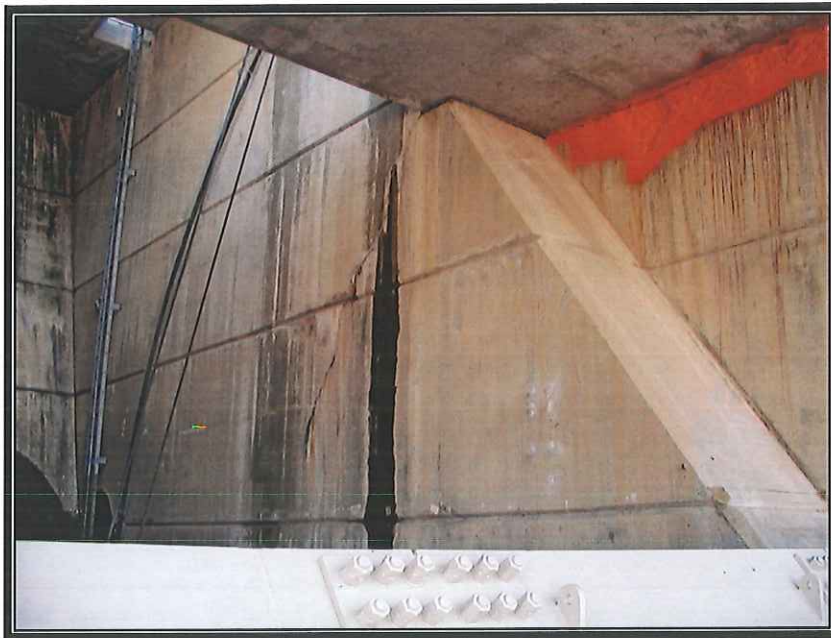
4. Note the seepage oozing from the existing diagonal crack at the left abutment of the flood control structure. Also shown is the new paint coating that is used to monitor spalling of the abutment. No new spalling has occurred at either abutment since the paint was applied.

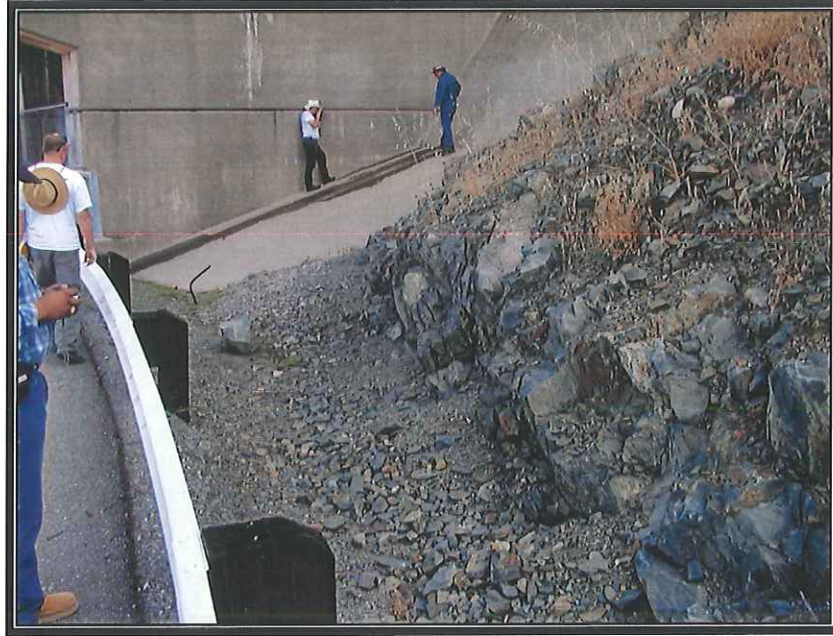
5. The spillway boat ramp access road is at left. Seepage is shown exiting at the toe of the buttress block, just left of the bay 8 wall. This is said to be typical when the reservoir is full. Damp ground was also noted in the drainage swale in the foreground. Water was also trickling from the rock in the middle of the photograph.

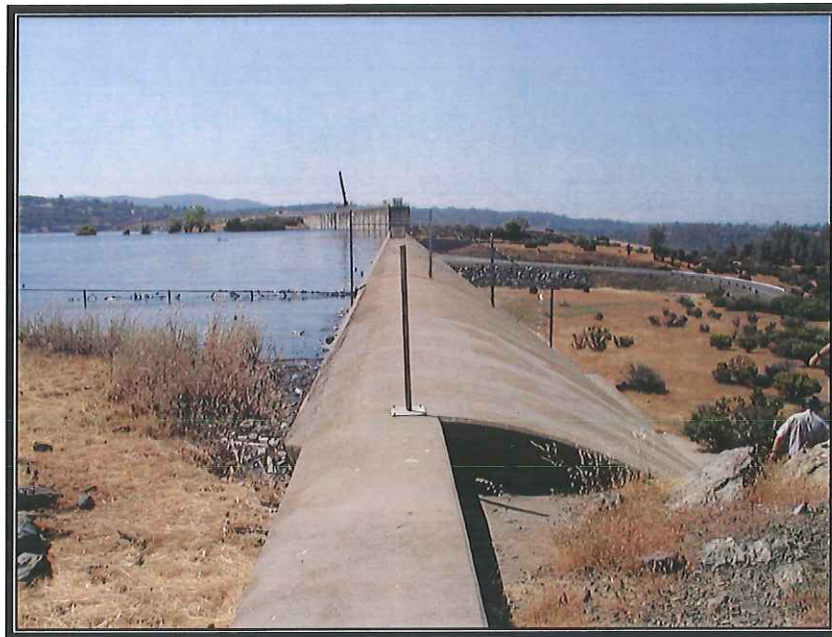
<p>The emergency spillway weir remains in good condition as shown in photograph 6. Where water was against the weir, minor seepage was observed along the downstream toe and at construction and lift joints. See photographs 7 and 8. The seepage is said to be decreasing as the reservoir level goes down.</p>

6. The south end of the emergency spillway is shown. The structure was in good condition with no misalignment or signs of distress.

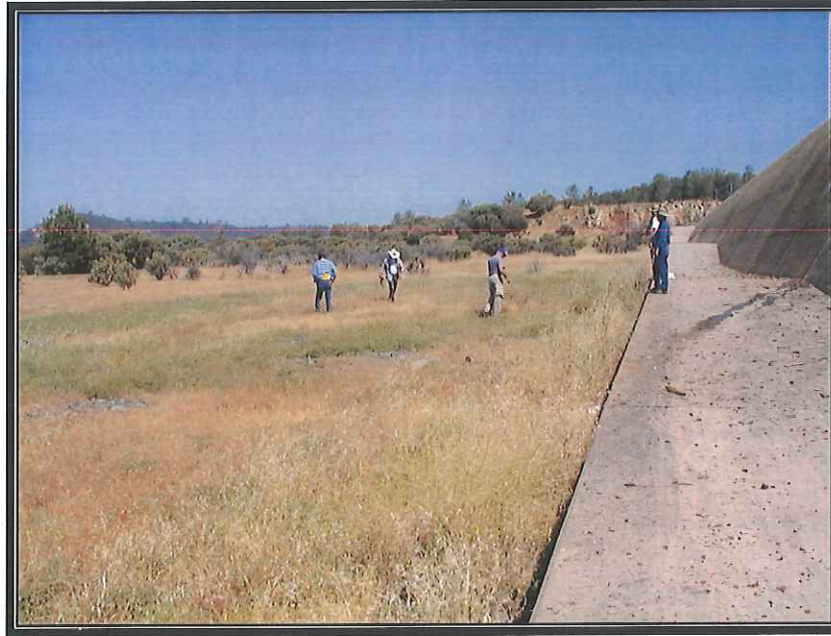
7. The toe of the emergency spillway is shown. This view is to the north. The green grass is in an area where seepage water was observed during the inspection. A small seep from a vertical construction joint is shown at right.

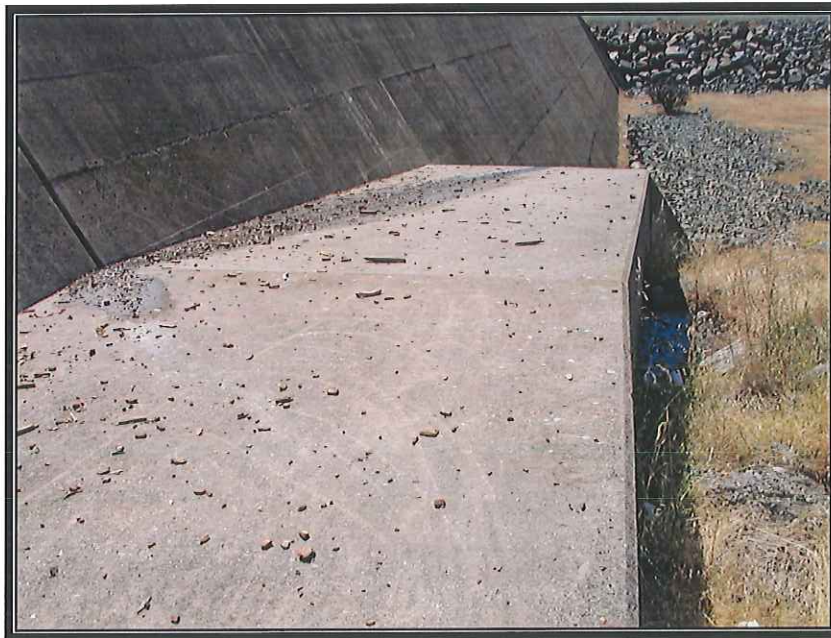
8. Another example of seepage from the emergency spillway weir is shown at left. Seepage was also noted at a few locations along the rock contact, and at lift lines along the top of the weir. None of the seepage appeared to be of particular concern.
